# **Damage detection versus Heat dissipation in E-Glass/Epoxy laminated composites under dynamic compression at high strain rate**

M. Tarfaoui (1), A. El Moumen (1,\*), H. Ben Yahia (1)

(1) ENSTA Bretagne, FRE CNRS 3744, IRDL, F-29200 Brest, France.

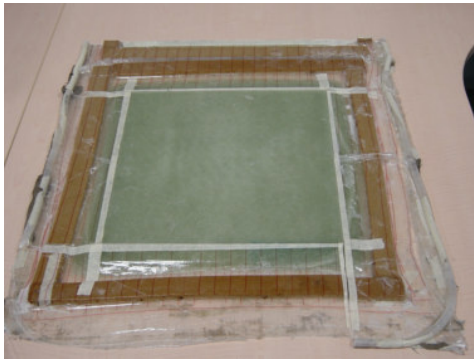
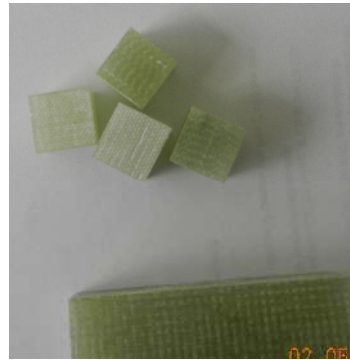
(a) Infusion process

(b) Specimen

Figure 1: Manufactured panels and specimens.

Composite laminates used in this study consists of 2400 Tex E-glass fibers embedded in an epoxy polymer matrix. The reinforcement consists of a plain weave fabric with 90% warp yarns and 10% weft yarns. The resin is an EPOLAM pre-polymer, EPOLAM 2020 hardener and 2020 accelerator from Axson. Panels of 500mm x 500mm were made by infusion process, Figure 1a, with 40 unidirectional layers, stacking sequence of  $[\pm 60]_{20}$  and an overall thickness of 13mm. The resin distribution over the whole laminate is aided by resin flowing easily through the tissue plies at ambient temperature.

The square specimen was cut into cubic shape, Figure 1b, with dimensions listed in Table 1. Static compression tests are conducted on cubic samples in order to obtain the elastic properties of the lamina. In-plane loading (IP), parallel to the layers plane and out-of-plane loading (OP), according to the thickness (direction 3) were considered. Strain gages were placed on the various facets of samples at different angles to measure the strain inside the specimen, Figure 2. Each test was repeated at least three times, and the results are recorded and averaged. The mechanical properties of specimens, obtained with static compression, are given in Table 2.

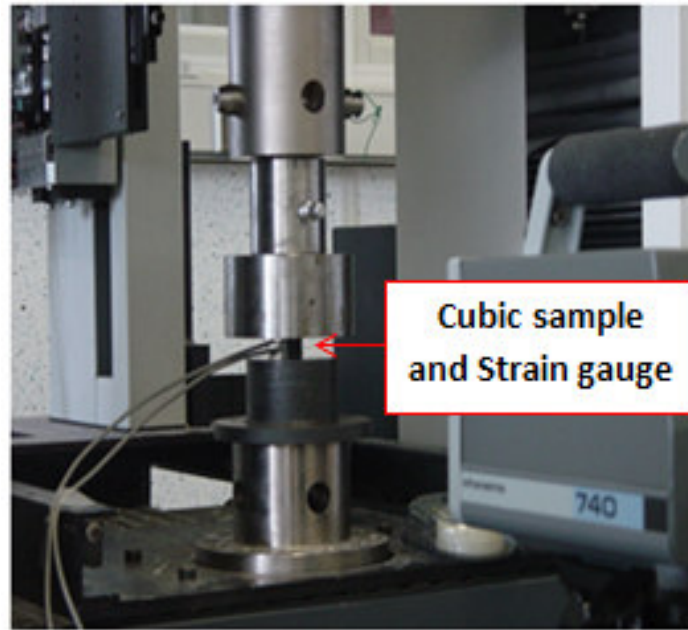
Figure 2: Static compression test of cubic samples and fixtures system.

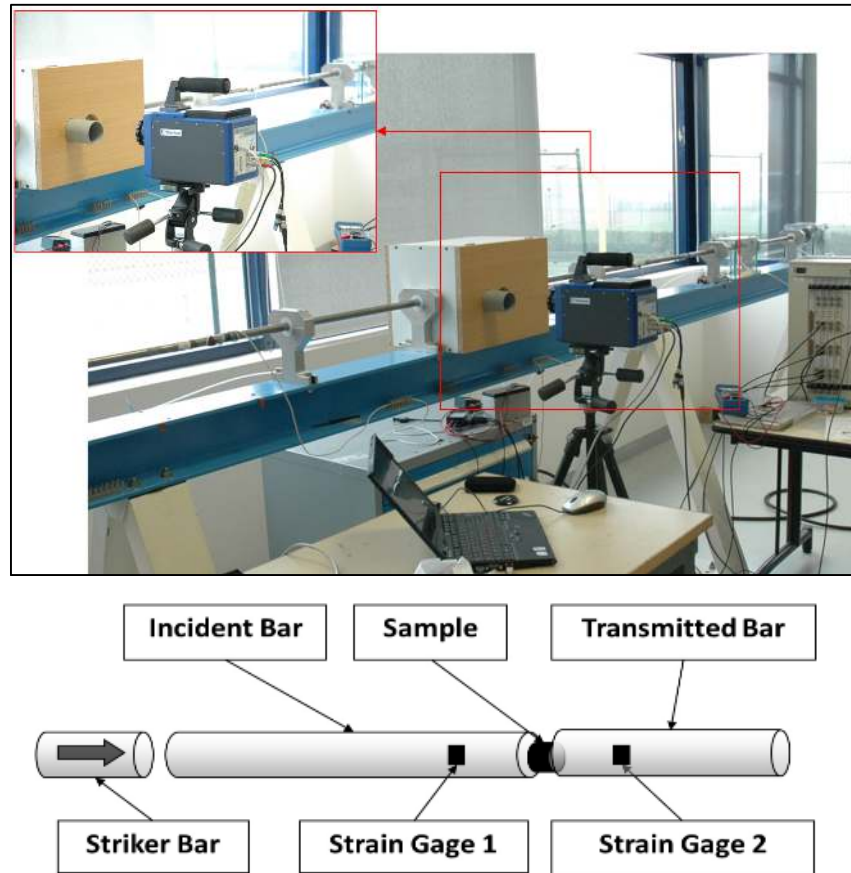
Figure 3: SHPB tests with full-field deformation and temperature measurements.

Tests are performed with the help of SHPB installed at the research center of ENSTA Bretagne, Figure 3, at different strain rate ranging from 200 to 2000 s<sup>-1</sup>. The SHPB mainly consists of an incident and transmitted bars, made of hardened steel with a diameter of 20 mm. The compression loading wave is generated by a striker impactor tube that impacts a flange at the far end of the incident bar. The full-field deformation during the impact tests is determined by using strain gauges. The photograph shown in Figure 3 shows a view of the experimental test machines. All of the tests are carried out according to the fibers direction of

$\pm 60^\circ$ . High-speed camera, with a maximal capacity of 100000 f/s is installed in front of impact chamber in order to track the initiation and propagation of damage. The thermal acquisition is measured with the help of FLIR SC7000 camera characterized by thermal resolution of 25 mK and acquisition frequency fixed to 2 kHz. The data recording is treated by Altair software. The specimens, with a cubic shape, are placed between bars as shown in Figure 4.

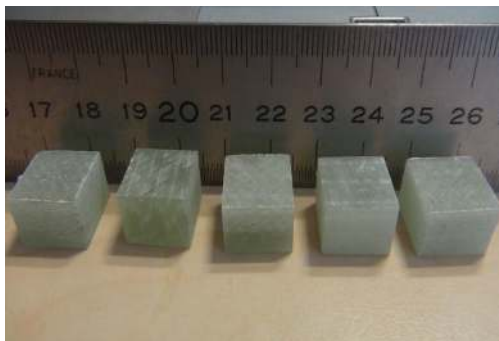
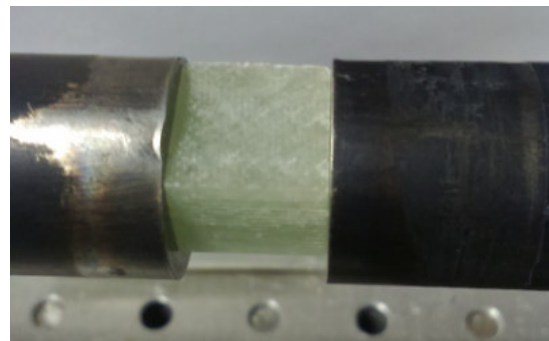
Figure 4: Specimen dimensions and fixture system.

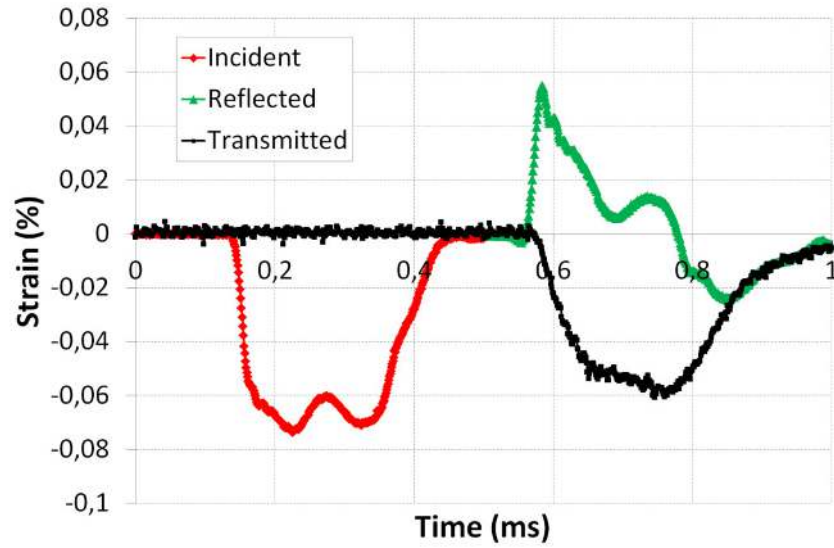
Figure 5: Typical incident, reflected and transmitted pulse,  $[\pm 60]_{20}$  and  $P=0.9\text{ bar}$  ( $831\text{ s}^{-1}$ ).

In this dynamic compression tests, a cubic sample is placed between the two bars with same diameter 20mm. The striker, incident and transmitted bars have a length of 0.8, 3 and 2m, respectively. These bars are correctly aligned and are able to slide freely on the base. The composite is not attached to the bar in order to prevent perturbations of measurements due to additional interfaces. The signals were treated with Maple Software using Fast Fourier Transformation to obtain the evolution of dynamic characteristics: Stress-strain, strain rate, load and velocities. The specimens were subjected to different impact pressure, and the resulting signals were recorded by a digital oscilloscope. For each test, a minimum of five tests were achieved for each pressure in order to verify the test reproducibility. Figure 5 gives an example of the typical signals obtained during a test carried out with the Hopkinson bars. This figure shows an example of the obtained signal as a function of impact time for a striker velocity equal to 12.5 m/s. It should be noted that the obtained curve is similar to one of Hopkinson bars which composed with the incident, transmitted and reflected waves. Upon impacting the input bar, the striker creates a compressive wave that traveled along the input bar. In the case shown below, the incident and the transmitted signals are given at the center of each bar. After 0.15ms, from the time impact, the compressive wave arrives at the middle of the input bar. At 0.58ms, a fraction of the wave is reflected at the input-bar free surface as a tensile wave. Due to the gap between the two bars, the input bar took approximately 0.1ms to reach the output bar and the duration of the transmitted wave was shorter than the incident wave. The duration of the incident wave is 0.4ms.

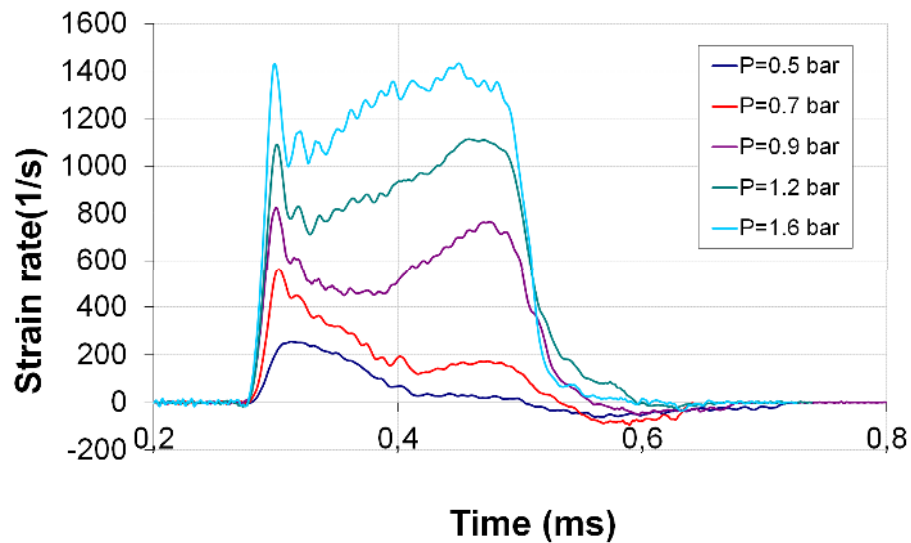
Figure 6: Strain rate vs. time for different impact pressures.

Furthermore, the input signals (in voltage) are converted to the average stress of the specimen via multiplying by the stress scale factor. Then the strain rate versus time and stress-strain curves can be obtained. Figure 6 shows the strain rate - time histories using different impact pressures (or different impact energy). These tests are conducted at laboratory temperature. The magnitude and duration of waves increase with the impact pressure. It is seen that the pulse is approximately 0.35ms long for 1.6bar and characterized by a trapezoidal shape, with a flat region, and by a decaying tail.

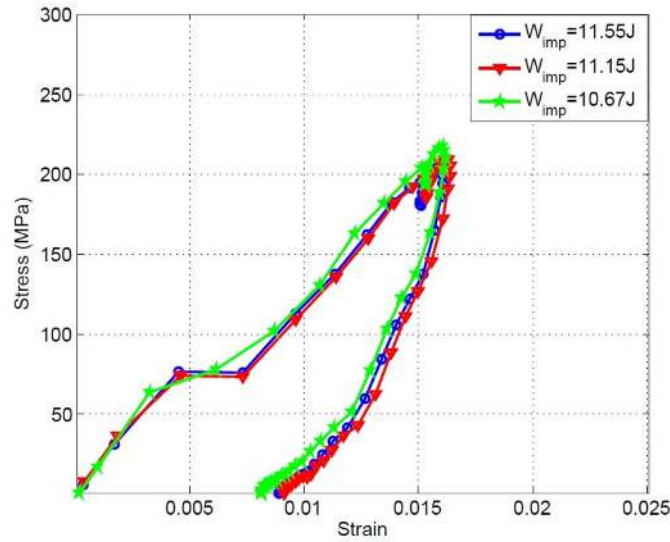
Figure 7: Reproducibility of experimental test.

Figure 7 shows the Stress-Strain curve obtained by impacting the specimens approximately with the same impact energy,  $W=11\text{J}$ , to ensure the reproducibility of the experimental procedure. It appears that all of the curves have a mountain-like shape and exhibit approximately the same trends. The three tests found the same maximum stress, 210 MPa, for the same strain, 1.65%.

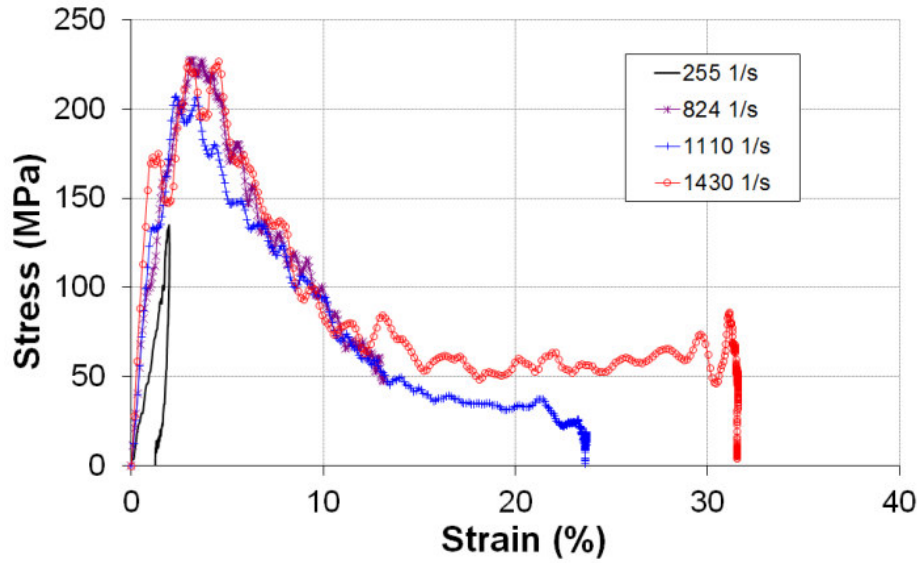
Figure 8: Stress–strain curves,  $T = 24^{\circ}\text{C}$ .

Now, the tests were done at strain rates ranging between 200 and 1500  $\text{s}^{-1}$  at ambient temperature. It follows from Figure 8 that the stress increases with increasing strain rate. The strain rate exerts a significant effect on the dynamic properties of composites subjected to Hopkinson bars.

We can also note that for strain rates less than  $255\text{ s}^{-1}$ , the damage is not present. On the other hand, when the strain rate exceeds  $800\text{ s}^{-1}$ , the damage becomes important and appears. Therefore, strain rate more than  $800\text{ s}^{-1}$  was used in order to control the evolution of damage vs heat dissipation and vs temperature profile.

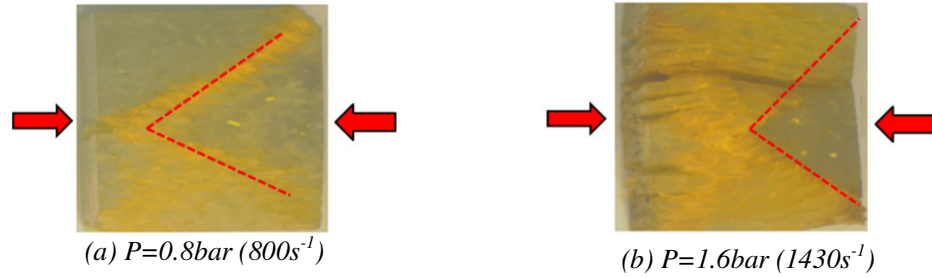
Figure 9: Damaged zone under dynamic compression test with Hopkinson bars.

This section is concerned with analysis and discussion of the apparition of damage in the specimens during impact tests. Considering, for example, the case of specimens impacted with 0.8 and 1.6 bar, corresponding to  $800$  and  $1430\text{ s}^{-1}$ , respectively. Figure 9 shows the impacted specimens. In these cases, three types of damage were observed: delamination, cracks in the plies direction and debonding. It appears from this figure that, for different strain rates, the damaged zone has the V-letter like-shape and propagates in the direction of fibers. The damaged zone becomes important for high strain rate,  $1430\text{ s}^{-1}$ , and this case is considered and analyzed for thermal analysis.

The evolution of damage in impacted specimens generates a shearing mode between the V zone and the rest of the specimen. Under the dynamic compression, there is also a buckling mode of the external layers resulting in local delamination for  $800\text{ s}^{-1}$  (0.8bar) and total delamination of ply for the case of  $1430\text{ s}^{-1}$  (1.6bar). The history of damage is given in Figure 10 for different impact times. At the end of the test, a great deformation is observed in

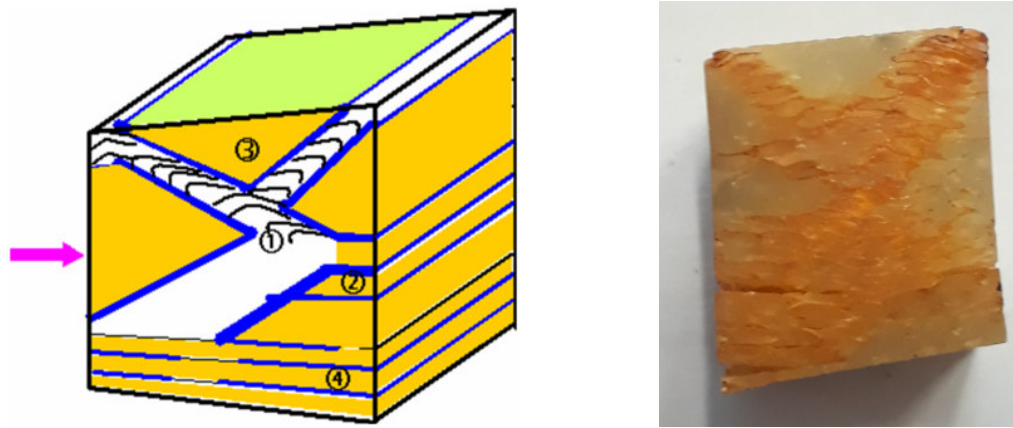
Figure 11: Damage history of  $[\pm 60]_{20}$  cubic sample at high impact pressure.

The damage kinetics of  $[\pm 60]_{20}$  laminate is summarized in Figure 11. The different damage modes observed are:

- ① Formation of the 1<sup>st</sup> damaged zone (V shape, Shear mode: local buckling, fiber kinking and matrix crack).
- ② “V” emerges by the creation of delamination.
- ③ Formation of the 2<sup>nd</sup> damaged zone (V shape).
- ④ Delamination (layers block separation) and total failure.

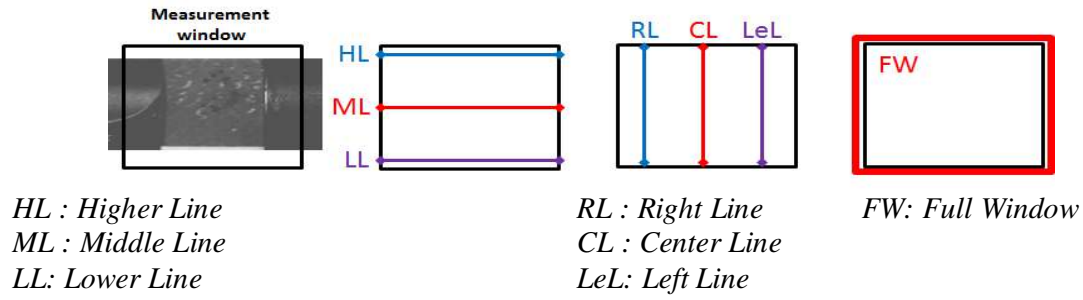
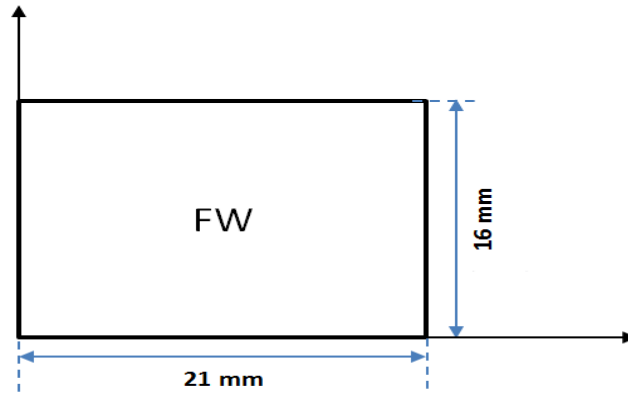
(a) Position of measurement

(b) Geometry of measurement area

Figure 12: Heat dissipation measurement area.

In order to characterize the dependence of the thermal dissipation on the damage, dynamic compression tests with SHPB apparatus are carried out with the positioning of the infrared camera to view the specimen surface opposite to that of impact. As mentioned, the purpose of this was to determine what the damage type including delamination and cracks generate a higher thermal dissipation. Sequences of thermal images are acquired at 2 kHz frame rate during an impact event. Each sequence of thermal images is post-processed in order to extract the corresponding temperature variations. The variation of temperature is taken in seven positions; namely: higher-line (HL), Middle-Line (ML), Lower-Line (LL), Right-Line (RL), Center-Line (CL), Left-Line (LeL) and Full-Window (FW), Figure 12.

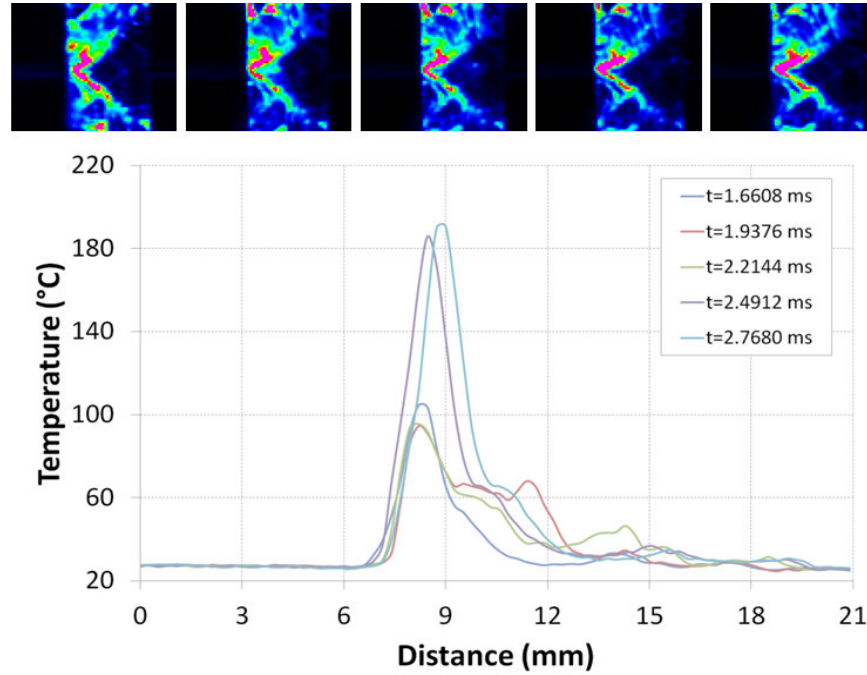
Figure 15: Thermal images recorded by the IR camera and the temperature history at ML, 3<sup>rd</sup> compression wave.

The temperature increases with impact time and reached its maximum peak, 190°C, at 2.7680ms, Figure 15. Hot spots enlarge and another appears forming a unique hot zone localized in the two branches of V, meaning that some important damages have locally occurred in the V branch and shearing mode is developing between the V zone and the rest of the specimen. The final hot spot takes V-shape follows the delamination evolution and failure of plies. Temperature increases from 75°C to 190°C.

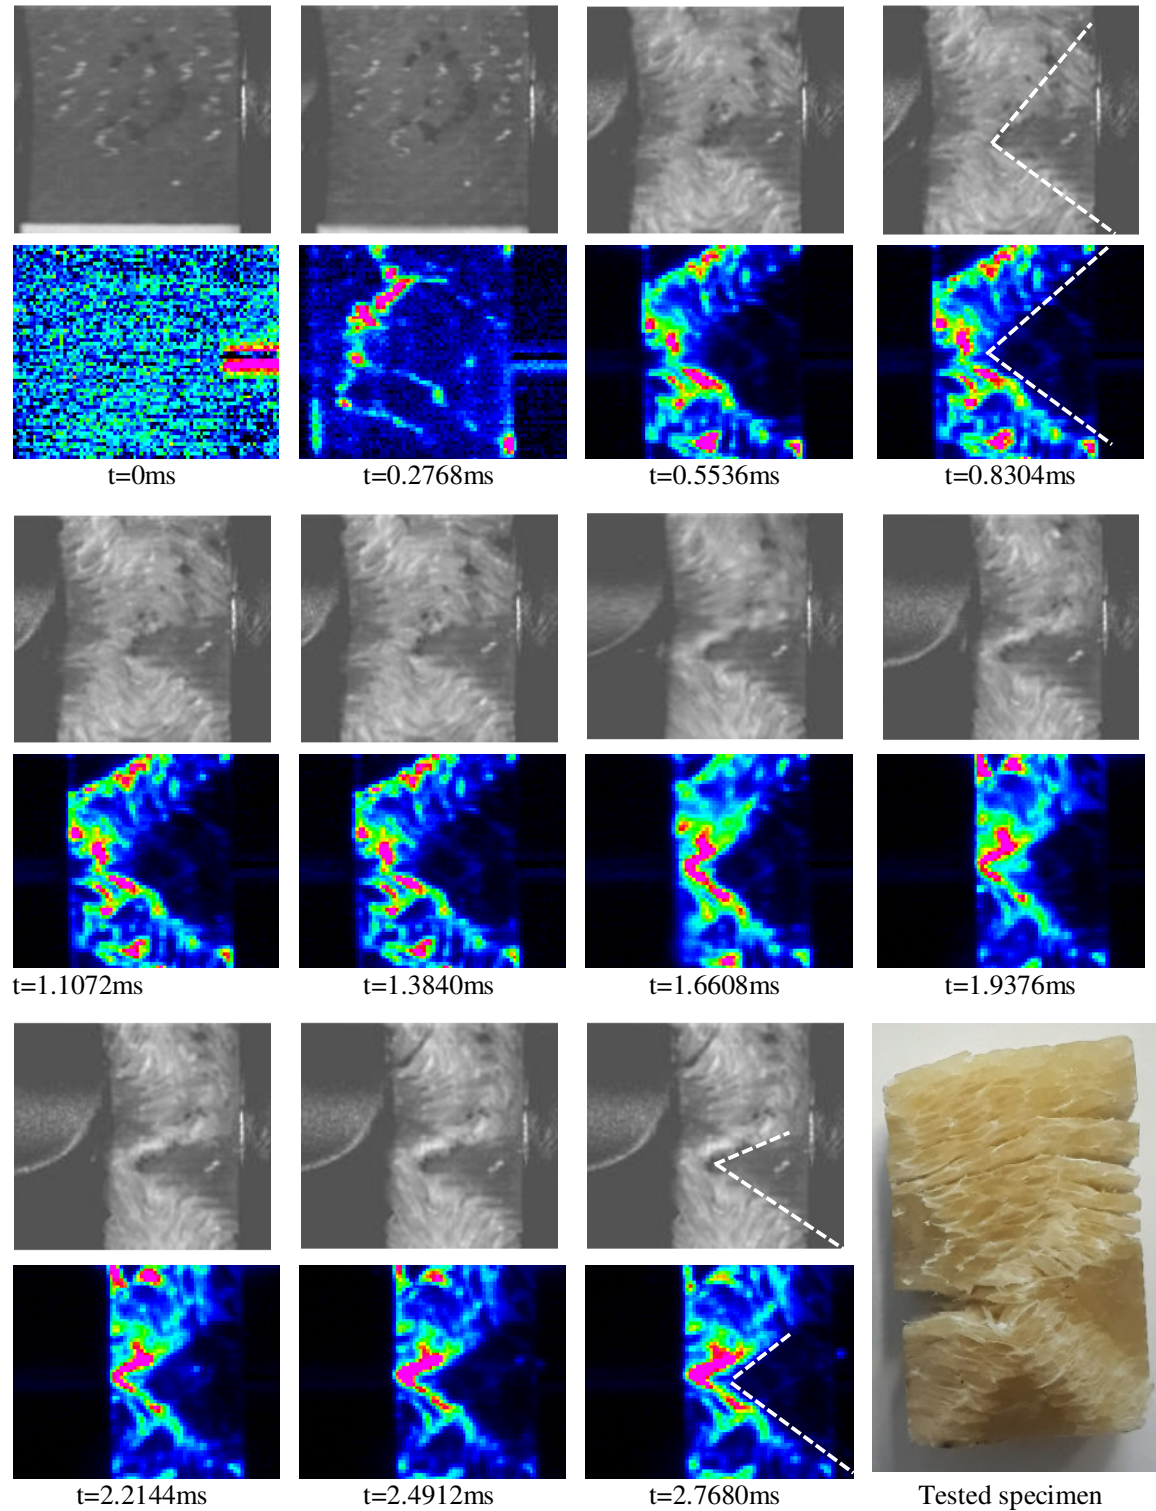
Figure 16: Thermal and visible images of the specimens impacted at  $1430 \text{ s}^{-1}$ .

For more illustration, a contoured thermal and visual image of the specimens under dynamic compression at  $1430\text{s}^{-1}$  is shown in Figure 16. For comparison, we have reported in this figure a photo of the specimen at the same impact time to show the contoured zone for temperature and damage profiles and the dependence of heat dissipation to damage which appears on composites during dynamic loading. As can be seen, there is a good correspondence between the two areas: the thermal and the visible damage one. In two images (IR vs Camera pictures), the V-letter like shape is observed and the temperature field follows the damage evolution from 0.5536ms of impact time. In particular, only different hot spots are present until 1.6608ms, at which another hot zone configuration is appeared and localized in the center taking V-shape. Then, it is not surprising to see dependence between heat

dissipation and damage evolution. Going further on in time, all the hot spots coalesce forming a unique V-hot zone. A wider area warmed up is localized in the center of specimens with larger delamination occurred.

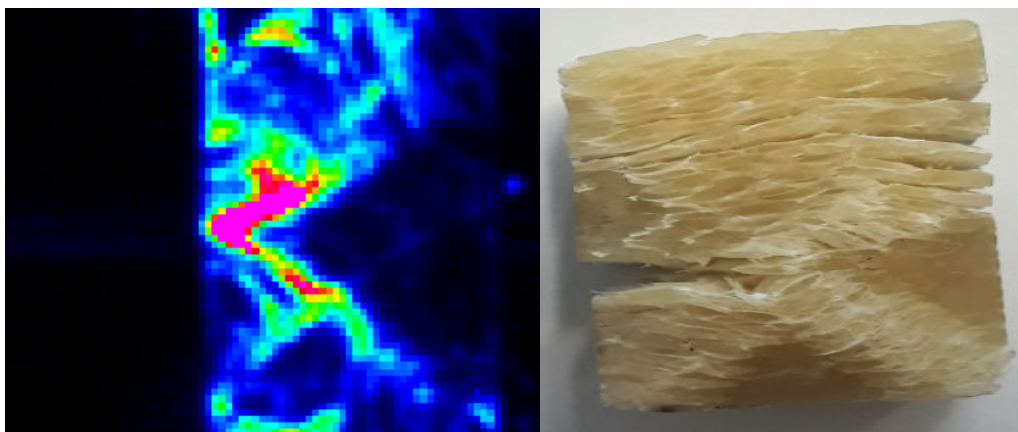
Figure 21: Superposition of infrared and optical images.

The characterization of heat generation in  $[\pm 60]_{20}$  is significant to understand the damage evolution. To gain information about the heat dissipation vs damage evolution, Figure 21 depicts the superposition of infrared and optical images for the damaged specimen. As can be seen, a hot zone, indicating maximum heat dissipation, appears at the center of the thermal image with a total rupture of plies as observed in the optical image. If the damage becomes more important; this is supported by the important heat dissipation and an abrupt temperature rise during the test. Therefore, moderate heat dissipation release occurs in the course of the fracture of specimens.
