# Fatigue behaviour of an industrial synthetic rubber

**Abstract.** For some automotive anti-vibration applications, for instance exhaust hangers, center bearing bushes or torsional vibration dampers, temperature constraints make the use of synthetic rubbers, such as EPDM, necessary because of their better heat aging resistance compared to natural rubber. The aim of this paper is to understand the features of the fatigue behaviour of an industrial EPDM compared to the well-known natural rubber. To do so, fatigue tests are conducted on hourglass-shaped specimens, and fracture surfaces are analysed using optical microscopy and scanning electron microscopy (SEM). It appears that every samples exhibit only one root cause of failure. Thus, two types of precursors are identified as responsible of the final fracture of samples: material's inclusions and mold flaws. Interrupted fatigue tests are then performed and fatigued samples are observed with SEM. The built procedure allows us to follow fatigue cracks initiation and propagation along cycles, and to propose local damage mechanisms for each type of precursors. A global damage scenario is finally considered and compared to the one of n

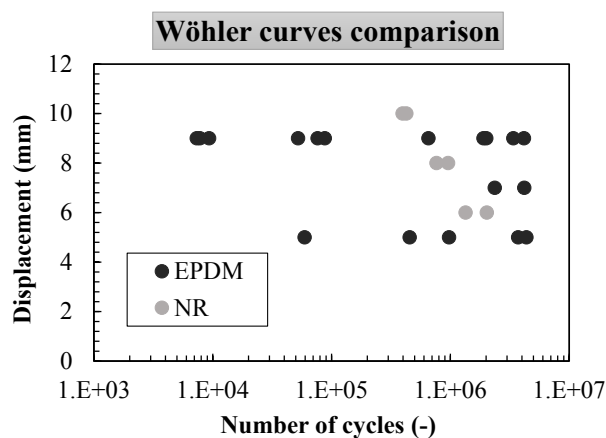
**Fig. 1.** Fatigue results scattering of EPDM compared to natural rubber (data from Flamm et al. [2]).

However, fatigue prediction for this material is difficult due to an important scattering of the lifetime results that can reach more than 4 decades (see Fig. 1).
