In-situ Strain Monitoring Performance of Flexible Nylon/Ag Conductive Fiber in Composites Subjected to Cyclic Tensile Loading

Yumna Qureshi, Mostapha Tarfaoui, Khalil K. Lafdi, Khalid Lafdi. In-situ Strain Monitoring Performance of Flexible Nylon/Ag Conductive Fiber in Composites Subjected to Cyclic Tensile Loading. European Workshop on Structural Health Monitoring, EWSHM 2020, Jul 2020, Online, France. pp.716-726, 10.1007/978-3-030-64594-6_69 . hal-03188796

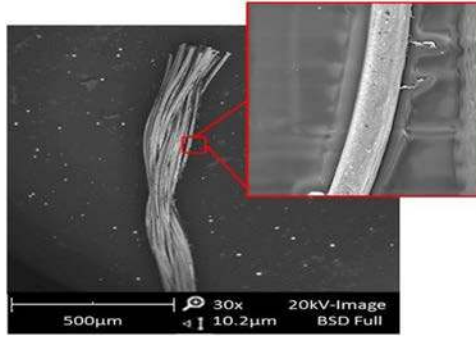
Fig. 1. SEM of Nylon/Ag fiber sensor after fabrication [25] wire

Nylon/Ag fiber sensors were developed by depositing Ag nanoparticles as a uniform continuous film on every filament of Nylon by using an electroless plating process [22, 23], (see Fig. 1). Then the fiber sensor was inserted between the plies of chopped glass fibers in their respective position and direction during the fabrication of the composite specimen. The chopped fiber mat ensured isotropic mechanical behavior with poor conductivity and electrical isolation for each fiber sensor. Nylon/Ag fiber sensors were inserted in the specimen in their particular direction such that sensor A was in 0° between plies 1 and 2, sensor B was in 45° between plies 2 and 3, sensor C was in 90° between plies 3 and 4 and sensor D was in -45° between plies 4 and 5 from bottom to top. After the mixture of resin and hardener was added into the mold and after the curing process of 48 h at room temperature, full insertion of fiber sensors was achieved in each specimen. The specimens were machined using CNC (Computer numerical control) machine in a star shape in which each leg represented the direction and placement of the fiber sensor, (see Fig. 2).

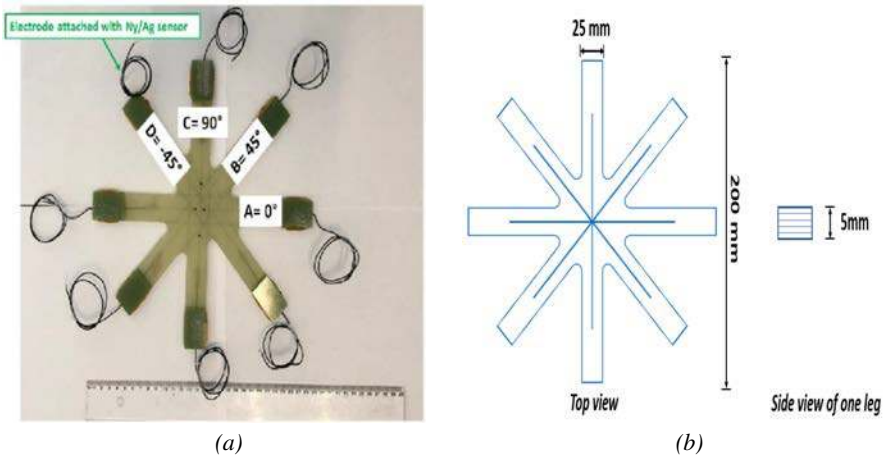
Fig. 2. (a) The composite samples turned transparent after the fabrication and embedded Nylon/Ag fiber sensors were visible in each leg. (b) Geometric Parameters and dimensions of the star specimen

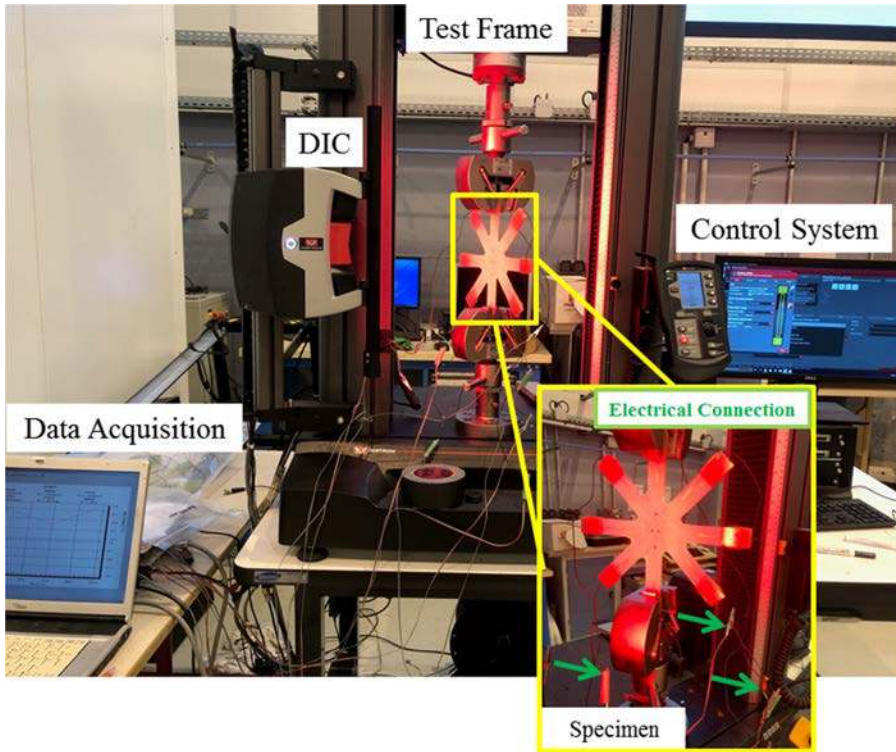
Fig. 3. Setup to examine the in-situ monitoring performance of the Nylon/Ag fiber sensor when integrated within the composite sample during a tensile test.

The star specimen was placed between the fixtures in the INSTRON-50 machine in such a manner that sensor A was along the loading axis and the data acquisition system was attached to the electrode wires connected to the Nylon/Ag fiber sensors, (see Fig. 3). It was vital to ensure that the sample was positioned properly among the fixtures and the electrical connections were isolated from any metallic part of the machine to avoid any external influence on the electrical response of the fiber sensors. Then, the test was performed at a low strain rate i.e. 5 mm/min up to 15 kN to avoid any permanent deformation and each test was performed for 10 cycles. The mechanical response of the specimen with the electrical profile of all four fiber sensors was obtained.

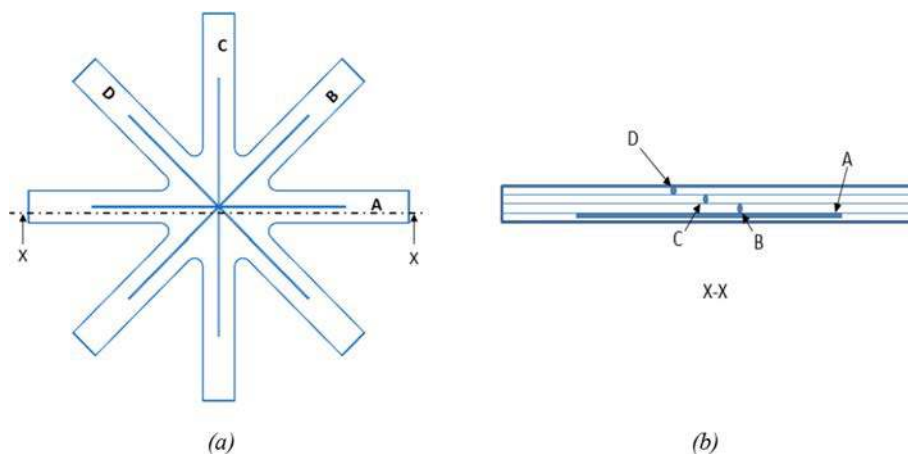
Fig. 4. Star Specimen with (a)–(b) Geometrical illustration of the placement of sensor systems in their individual sample i.e. in individual leg and through-thickness (section view) correspondingly.

First, it is important to understand the strain deformation of the composite under cyclic tensile loading to apprehend the strain detection by all three sensor systems, (see Fig. 4). One leg of the star specimen was fixed between the fixtures of the machine and the other legs were free. The loading axis was considered as the reference and sensor place in this direction was at 0° and labeled as sensor A. When the specimen was loaded, tensile stresses were produced in 0° and compression stresses were produced in 90° i.e. transverse direction. In addition, it was understood that the combined effect of tensile and compression stresses is generated in oblique direction i.e. $+45^\circ$. However, in test 1 and 2, samples were placed between the fixtures in such manner that the leg of the star sample consisting of sensor A was along the loading axis i.e. in 0° and in test 3,

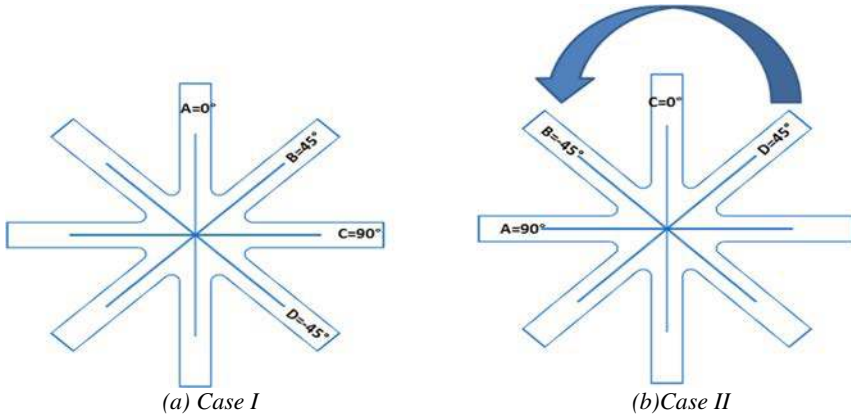
Fig. 5. Position of the composite star samples between the fixture for tensile loading: (a) Sample placement in tests 1 and 2, (b) Sample placement in a test.

the sample was placed in a way that the leg of the composite sample consisting of sensor C was along the loading axis i.e. in 0° , sensor A in 90° and sensor B & D interchanged their position for all three sensor systems, (see Fig. 5). The step to interchange the positions of the sensor in test 3 was conducted to examine the load sensitivity of each sensor system and it didn't affect the comparison of the mechanical performance of the composite samples. Three composite specimens were tested for each sensor system successfully, and mechanical behavior was plotted as elastic modulus and overall initial stress-strain curve which showed good repeatability in the behavior. Figure 6 shows a comparison of three samples and results confirmed that the mechanical behavior of all composite samples was similar irrespective of the choice of the loaded leg or the sensor system and was isotropic because of the use of the chopped glass fiber mat. The presence of any sensor system in different directions and positions did not affect the structure's integrity. Moreover, the mechanical behavior of all the three star-samples was similar to each other regardless of the placement of the specimen. This further confirmed that the placement of fiber sensors at different positions [21] and directions did not influence the mechanical behavior and integrity of the composite sample and its isotropic nature.

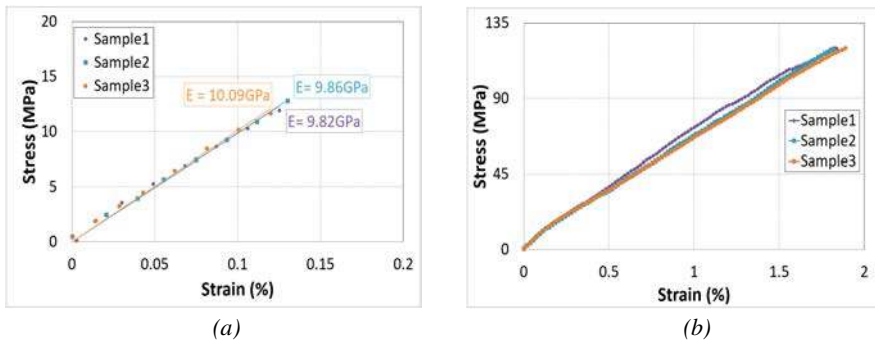
Fig. 6. Mechanical behavior of all three star-samples. (a) Elastic modulus (b) Overall tensile stress-strain behavior

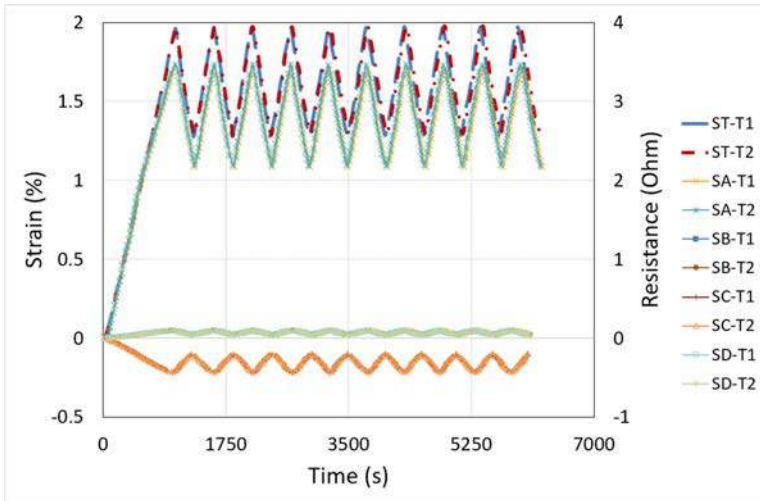
Fig. 7. Real-time strain (ST) monitoring by Nylon/Ag fiber sensor in the composite star specimen during cyclic tensile loading. In both tests 1 (T1) and 2 (T2), sensor A (SA) was along the loading axis, sensor B (SB) at 45°, sensor C (SC) at 90° and sensor D (SD) in -45°.

- Test 1 and Test 2 confirmed the reproducibility of electrical response and the real-time strain monitoring behavior of the Nylon/Ag fiber sensor. All sensors A, B, C, and D showed changed in resistance during the deformation and correlated perfectly in both tests, (see Fig. 7). Moreover, it was observed that the maximum increase in resistance was recorded by sensor A which confirmed maximum tensile deformation occurred in the loading direction. However, sensor C showed a decrease in resistance and this negative behavior confirmed the presence of compressive stress and deformation which established the Poisson's effect during the deformation of the structure. The compression strains are dominant in the transverse direction while very less tensile strain present. That is why, the sensor in the C leg showed decrease in resistance detecting the presence of compressive strains. The minimum change in resistance was recorded by sensors B and D and both sensors showed identical responses. This identical response of sensors B and D was because in isotropic material, these two directions are a mirror of each other regarding the loading axis. However, slight diminution with less than 1% was recorded for the sensor A in comparison with the sensor B, C, and D. This reduction was negligible in comparison to the overall behavior during the cyclic loading. Nevertheless, the reason behind this behavior of sensor A was because sensor A was placed in the loading direction and was experiencing the maximum effect of the applied strain. Moreover, the applied cyclic strain was applied between 1–2% which is within the plastic deformation regime. Sensor A might experience minute permanent deformation during cyclic tensile and compressive strain because of the Poisson's effect during the loading and unloading of the cyclic load.

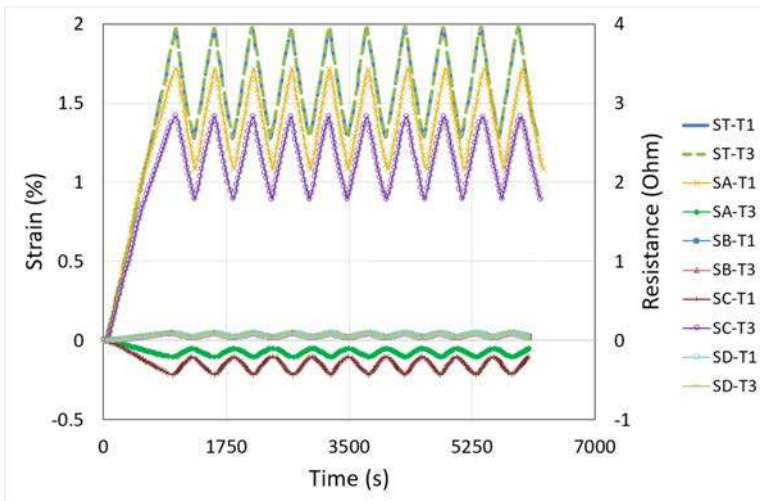
Fig. 8. Real-time strain monitoring by Nylon/Ag fiber sensor during cyclic tensile strain. In test-1 (T1), sensor A (SA) was along the loading axis, sensor B (SB) at 45°, sensor C (SC) at 90° and sensor D (SD) in -45° while in test-3 (T3) the specimen was placed transversely with respect to the specimen 1 and sensor C (SC) was along the loading axis, sensor D (SD) at 45°, sensor A (SA) at 90° and sensor B (SB) in -45°.

- Test 3 was performed and compared with Test 1 to check the sensitivity of the Nylon/Ag fiber sensor with respect to the loading axis, (see Fig. 8). This comparison was carried out to not only confirm the strain detection response of the Nylon/Ag fiber sensor but also showed its sensitivity to the applied load or loading direction. Sensor C recorded the maximum increase in resistance in test 3 because it was placed in the loading direction while sensor A showed a decrease in resistance because it was in a transverse direction regarding the loading axis. However, sensors B and D showed similar behavior in both tests because of their identical response in both directions i.e. $+45^\circ$. Moreover, it was observed that the change in resistance was the same in each direction in both tests irrespective of the sensor. For example, sensor A in test 1 and sensor C in test 3 showed a similar change in resistance because both placed along the loading axis. This confirmed that the sensitivity of the sensor was dependent on its position and direction of the applied load otherwise the response of each sensor A, B, C, and D can be similar, and, in every case, the strongest signal was recorded along the loading direction.
