In-situ Strain Monitoring Performance of Flexible Nylon/Ag Conductive Fiber in Composites Subjected to Cyclic Tensile Loading

Yumna Qureshi, Mostapha Tarfaoui, Khalil K. Lafdi, Khalid Lafdi

Yumna Qureshi, Mostapha Tarfaoui, Khalil K. Lafdi, Khalid Lafdi. In-situ Strain Monitoring Performance of Flexible Nylon/Ag Conductive Fiber in Composites Subjected to Cyclic Tensile Loading. European Workshop on Structural Health Monitoring, EWSHM 2020, Jul 2020, Online, France. pp.716-726, 10.1007/978-3-030-64594-6_69 . hal-03188796

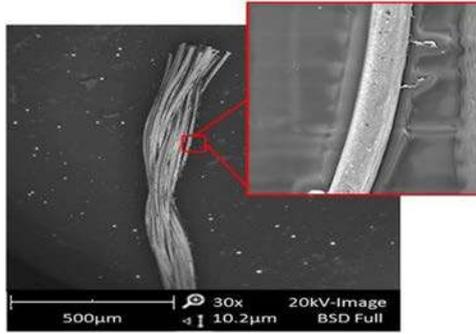
Fig. 1. SEM of Nylon/Ag fiber sensor after fabrication [25] wire

Nylon/Ag fiber sensors were developed by depositing Ag nanoparticles as a uniform continuous film on every filament of Nylon by using an electroless plating process [22, 23], (see Fig. 1). Then the fiber sensor was inserted between the plies of chopped glass fibers in their respective position and direction during the fabrication of the composite specimen. The chopped fiber mat ensured isotropic mechanical behavior with poor conductivity and electrical isolation for each fiber sensor. Nylon/Ag fiber sensors were inserted in the specimen in their particular direction such that sensor A was in 0° between plies 1 and 2, sensor B was in 45° between plies 2 and 3, sensor C was in 90° between plies 3 and 4 and sensor D was in -45° between plies 4 and 5 from bottom to top. After the mixture of resin and hardener was added into the mold and after the curing process of 48 h at room temperature, full insertion of fiber sensors was achieved in each specimen. The specimens were machined using CNC (Computer numerical control) machine in a star shape in which each leg represented the direction and placement of the fiber sensor, (see Fig. 2).

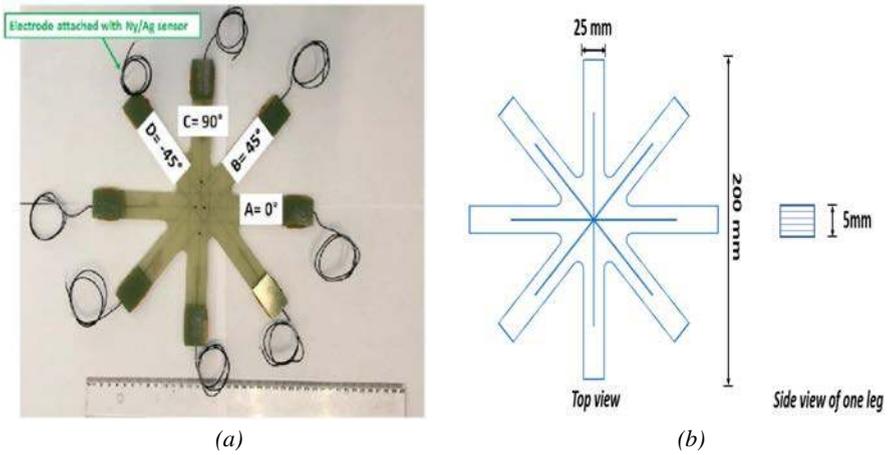
Fig. 2. (a) The composite samples turned transparent after the fabrication and embedded Nylon/Ag fiber sensors were visible in each leg. (b) Geometric Parameters and dimensions of the star specimen

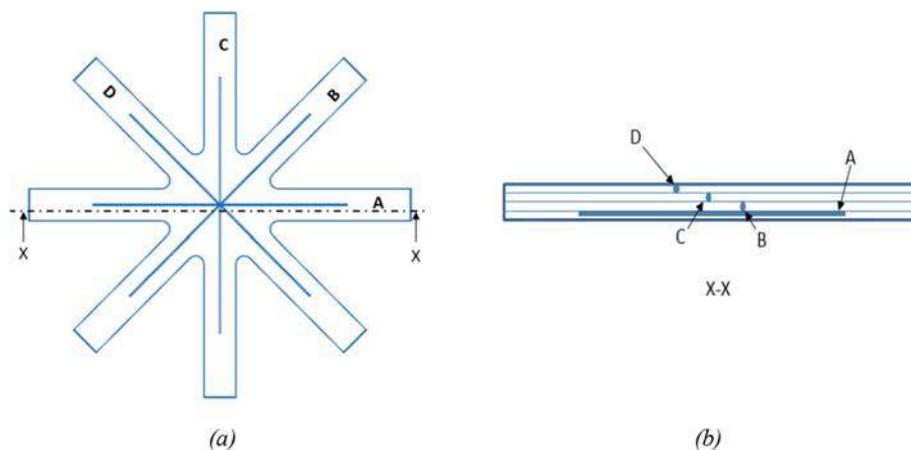
Fig. 4. Star Specimen with (a)–(b) Geometrical illustration of the placement of sensor systems in their individual sample i.e. in individual leg and through-thickness (section view) correspondingly.

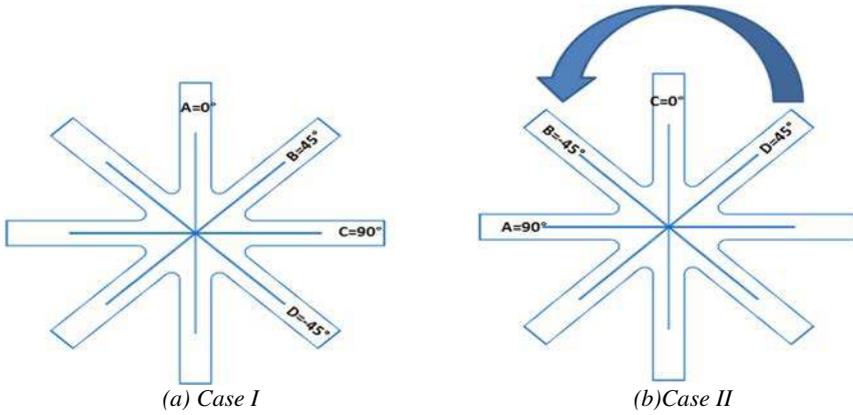
Fig. 5. Position of the composite star samples between the fixture for tensile loading: (a) Sample placement in tests 1 and 2, (b) Sample placement in a test.

the sample was placed in a way that the leg of the composite sample consisting of sensor C was along the loading axis i.e. in 0° , sensor A in 90° and sensor B & D interchanged their position for all three sensor systems, (see Fig. 5). The step to interchange the positions of the sensor in test 3 was conducted to examine the load sensitivity of each sensor system and it didn't affect the comparison of the mechanical performance of the composite samples. Three composite specimens were tested for each sensor system successfully, and mechanical behavior was plotted as elastic modulus and overall initial stress-strain curve which showed good repeatability in the behavior. Figure 6 shows a comparison of three samples and results confirmed that the mechanical behavior of all composite samples was similar irrespective of the choice of the loaded leg or the sensor system and was isotropic because of the use of the chopped glass fiber mat. The presence of any sensor system in different directions and positions did not affect the structure's integrity. Moreover, the mechanical behavior of all the three star-samples was similar to each other regardless of the placement of the specimen. This further confirmed that the placement of fiber sensors at different positions [21] and directions did not influence the mechanical behavior and integrity of the composite sample and its isotropic nature.

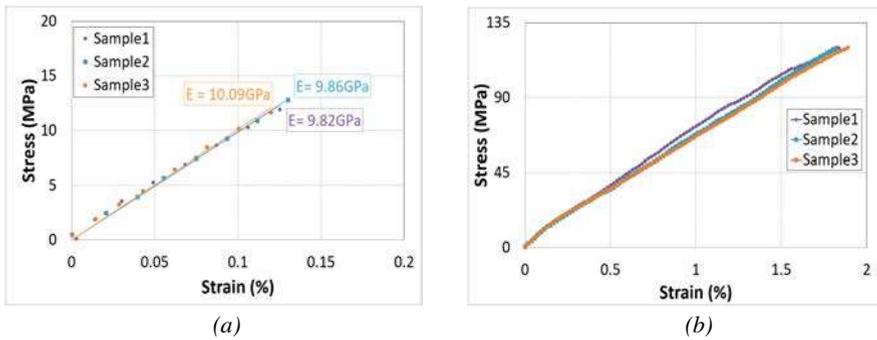
Fig. 6. Mechanical behavior of all three star-samples. (a) Elastic modulus (b) Overall tensile stress-strain behavior

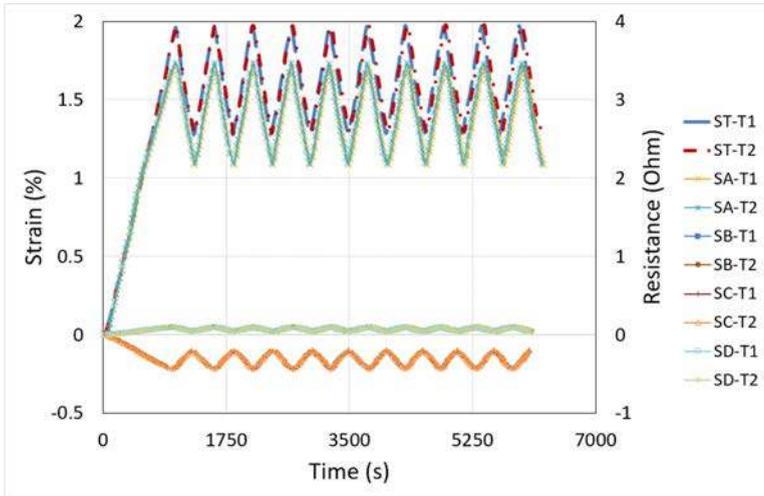
Fig. 7. Real-time strain (ST) monitoring by Nylon/Ag fiber sensor in the composite star specimen during cyclic tensile loading. In both tests 1 (T1) and 2 (T2), sensor A (SA) was along the loading axis, sensor B (SB) at 45°, sensor C (SC) at 90° and sensor D (SD) in -45°.

- Test 1 and Test 2 confirmed the reproducibility of electrical response and the real-time strain monitoring behavior of the Nylon/Ag fiber sensor. All sensors A, B, C, and D showed changed in resistance during the deformation and correlated perfectly in both tests, (see Fig. 7). Moreover, it was observed that the maximum increase in resistance was recorded by sensor A which confirmed maximum tensile deformation occurred in the loading direction. However, sensor C showed a decrease in resistance and this negative behavior confirmed the presence of compressive stress and deformation which established the Poisson's effect during the deformation of the structure. The compression strains are dominant in the transverse direction while very less tensile strain present. That is why, the sensor in the C leg showed decrease in resistance detecting the presence of compressive strains. The minimum change in resistance was recorded by sensors B and D and both sensors showed identical responses. This identical response of sensors B and D was because in isotropic material, these two directions are a mirror of each other regarding the loading axis. However, slight diminution with less than 1% was recorded for the sensor A in comparison with the sensor B, C, and D. This reduction was negligible in comparison to the overall behavior during the cyclic loading. Nevertheless, the reason behind this behavior of sensor A was because sensor A was placed in the loading direction and was experiencing the maximum effect of the applied strain. Moreover, the applied cyclic strain was applied between 1–2% which is within the plastic deformation regime. Sensor A might experience minute permanent deformation during cyclic tensile and compressive strain because of the Poisson's effect during the loading and unloading of the cyclic load.

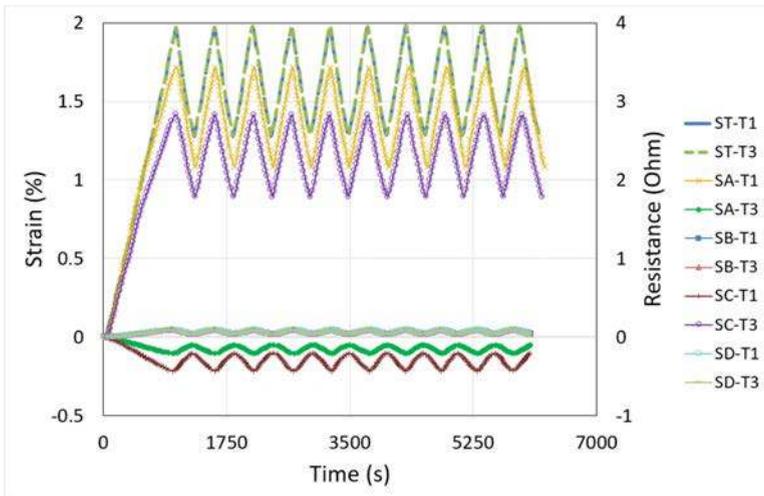
Fig. 8. Real-time strain monitoring by Nylon/Ag fiber sensor during cyclic tensile strain. In test-1 (T1), sensor A (SA) was along the loading axis, sensor B (SB) at 45°, sensor C (SC) at 90° and sensor D (SD) in -45° while in test-3 (T3) the specimen was placed transversely with respect to the specimen 1 and sensor C (SC) was along the loading axis, sensor D (SD) at 45°, sensor A (SA) at 90° and sensor B (SB) in -45°.

- Test 3 was performed and compared with Test 1 to check the sensitivity of the Nylon/Ag fiber sensor with respect to the loading axis, (see Fig. 8). This comparison was carried out to not only confirm the strain detection response of the Nylon/Ag fiber sensor but also showed its sensitivity to the applied load or loading direction. Sensor C recorded the maximum increase in resistance in test 3 because it was placed in the loading direction while sensor A showed a decrease in resistance because it was in a transverse direction regarding the loading axis. However, sensors B and D showed similar behavior in both tests because of their identical response in both directions i.e. $+45^\circ$. Moreover, it was observed that the change in resistance was the same in each direction in both tests irrespective of the sensor. For example, sensor A in test 1 and sensor C in test 3 showed a similar change in resistance because both placed along the loading axis. This confirmed that the sensitivity of the sensor was dependent on its position and direction of the applied load otherwise the response of each sensor A, B, C, and D can be similar, and, in every case, the strongest signal was recorded along the loading direction.
