Influence of defects size on the fatigue properties of an industrial EPDM

Thomas Balutch, Bertrand Huneau, Yann Marco, Pierre Charrier, Clément Champy

Thomas Balutch, Bertrand Huneau, Yann Marco, Pierre Charrier, Clément Champy. Influence of defects size on the fatigue properties of an industrial EPDM. 11th European Conference on Constitutive Models for Rubber (ECCMR 2019), Jun 2019, Nantes, France. 10.1201/9780429324710-62 . hal-02304552

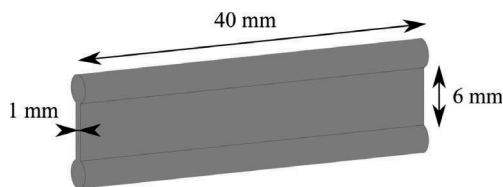
Figure 1. PS sample geometry.

The samples used to perform the fatigue tests are Pure Shear (PS) samples with dimensions 6x40x1 mm (Figure 1). It has to be noted that this sample geometry is usually used for fatigue crack propagation measurements. It is chosen in this study because it is more convenient to introduce calibrated defects in this geometry and to monitor fatigue cracks around them than it is on 3D specimens. In order to be representative of natural defects, the calibrated holes sizes must be in the same order of magnitude, which is approximately 0.1 mm (Balutch et al. 2018). The best way to perform a 1 mm deep defect of such a size is drilling. Consequently, small drills made of titanium alloy (Figure 2), provided by Mikron Tool, are used. The drilling is done in the glassy

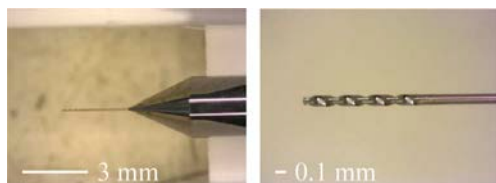
Figure 2. Titanium drill of diameter 0.1 mm.

state of the studied EPDM rubber, around -70 C, in order not to damage the rubber around the hole. At the end, PS samples have one hole in their center, and the number of specimens corresponding to each hole diameter is reported in Table 1.

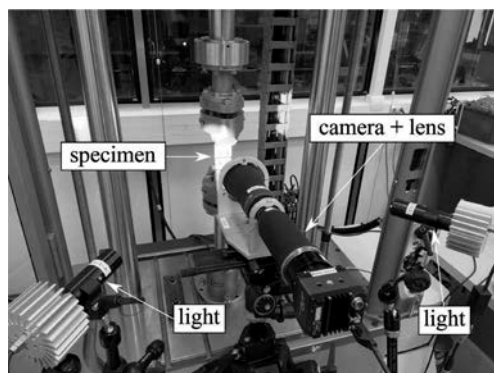
Figure 3. Experimental device.

In order to analyze fatigue crack initiation and propagation around defects, the fatigue test is interrupted every 200 cycles. The sample is then stretched to 3 mm during 2 seconds and a picture is taken. Therefore, a camera is installed in front of the specimen, and is triggered by the tensile machine (Figure 3).

The camera installed in front of the specimen is a Prosilica GT6600 from Allied Vision with a resolution of 6576*4384 pixels, and a bi-telecentric lens TC16M056 from OPTO engineering is used. The size of the pixel is equal to 8.55, and the distortion is below 0.1 %. The crack detection highly depends on this resolution, and a different experimental device would lead to a slightly different split between crack

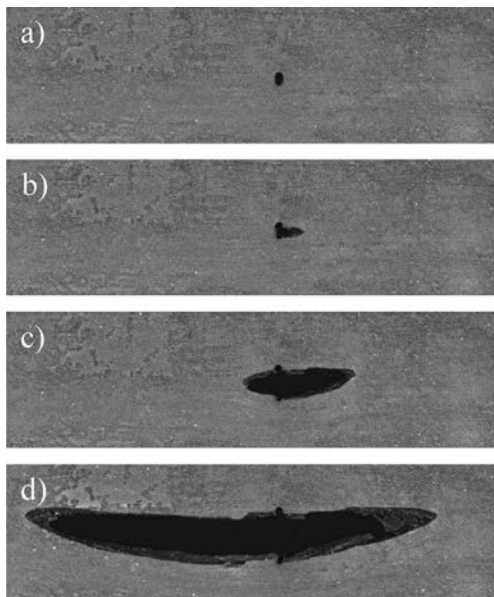
Figure 5. PS sample with a 0.2 mm hole at a) N = 0 cycle b) N = 109 400 cycles c) N = 112 600 cycles and d) N = 116 400 cycles.

Secondly, a damage description is proposed on Figure 5 thanks to regular pictures taken during fatigue tests. A first fatigue crack initiates on one side of the calibrated defect (Figure 4b), and few cycles later, another crack initiates on the opposite side (Figure 4c). They finally both propagate until final failure occurs. Figure 4d shows the sample just before failure. Each sample exhibits only one root cause of failure.

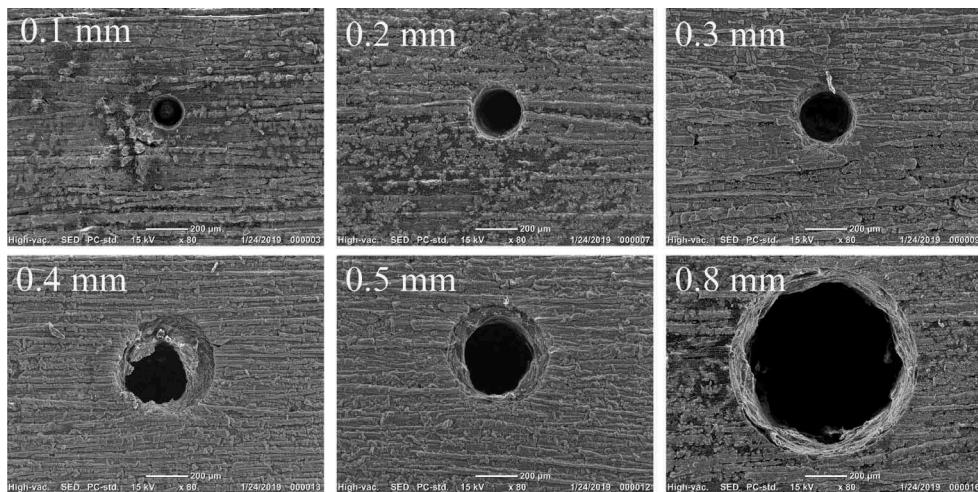
Figure 4. SEM pictures of the different hole sizes at the same magnification (x80).

In the first place, it has to be noted that small calibrated defects of good quality are successfully obtained. SEM pictures of all the tested defects sizes are presented in Figure 4. The rubber around the holes seems not burned or dragged by the drilling. This can only be obtained by performing the drilling in the glassy state of the rubber as mentioned in the methods section.

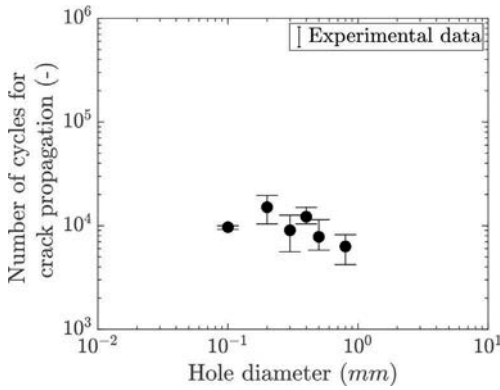
Figure 6. Hole diameter influence on the number of cycles for crack propagation.

given drill diameter. Figure 6 shows that the number of cycles for fatigue crack propagation is almost constant regardless of the hole diameter. In other words, as soon as a crack is visible, the number of cycles to propagate this crack until final failure is not much dependent on the defects size.

Another point is that Figures 6-7 prove that the total duration life is mainly driven by the fatigue “crack initiation” stage, the crack propagation stage being more or less constant for every samples. The strong influence of the defects size on Figure 6 suggests that the fatigue crack initiation stage must be studied to fully understand the fatigue behaviour of

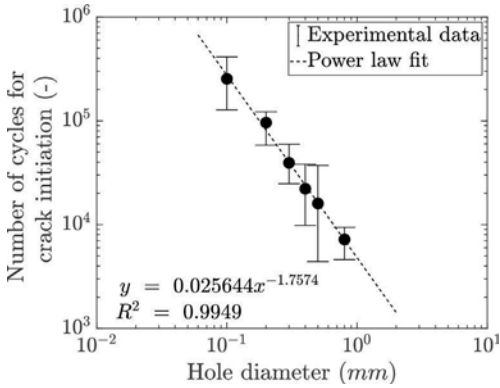
Figure 7. Hole diameter influence on the number of cycles for crack initiation.

Similarly, the Figure 7 represents the number of cycles for “crack initiation” as a function of the hole diameter. Unlike for propagation stage, it appears that the curve follows a decreasing power law with a good correlation coefficient. Thus, the bigger the size of the defect is, the shorter the number of cycles for “crack initiation” is, and this is in accordance with the literature (Huneau et al. 2016, Abraham et al. 2005).

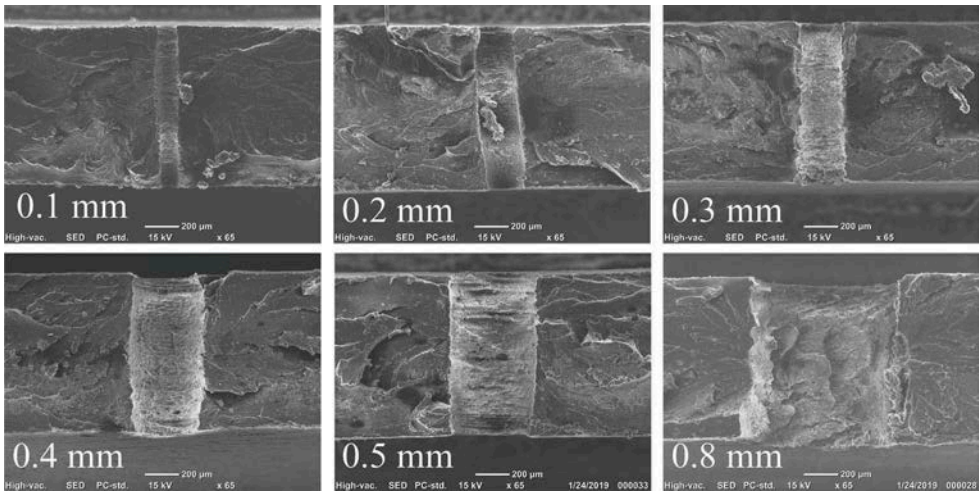
Figure 8. SEM pictures of fracture surfaces for each hole size at the same magnification (x65).

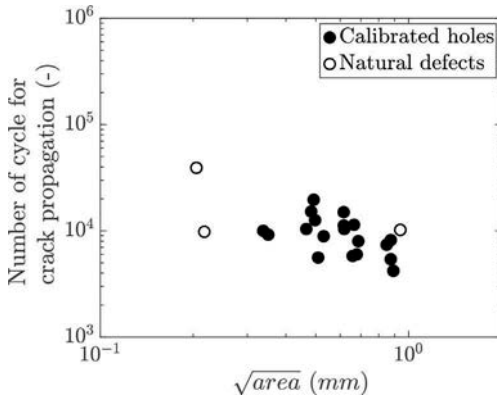
Figure 9. Defect $\sqrt{\text{area}}$ influence on the number of cycles for fatigue crack propagation.

Considering that geometrical features are the easiest parameters to quantify, the square root of the projected area in the tensile direction of the defect that led to failure is measured for all samples. This allows plotting on the same curve the results for natural defects and calibrated holes. It has been initially proposed by Murakami and Endo (1983), and is still used nowadays in fatigue of metals to represent the defects size (Houria et al. 2015, Le et al. 2016). This area is measured thanks to fracture surfaces analysis (Figure 8) and plotted versus the number of cycles for crack propagation (Figure 8) and the number of cycles for “crack initiation” on the Figure 10. The black points correspond to calibrated holes, and the black circles correspond to natural defects. The Figures 9-10 show that natural defects and calibrated holes seem aligned on one master curve. It appears that the defects size has a minor influence on crack propagation stage compare to crack initiation stage. Furthermore, Figure 9 shows that a variation of 1 decade in the \sqrt{area} of the defect responsible of the failure roughly leads to a variation of 2 decades in the number of cycles for fatigue crack initiation. Regarding the fatigue results of EPDM (Flamm et al. 2008, Balutch et al. 2018), it is common to observe more than 2 decades of scatter in the fatigue lifetime results. Hence, the variation of the defects size could explain a part of the scatter in the fatigue lifetime of such material.

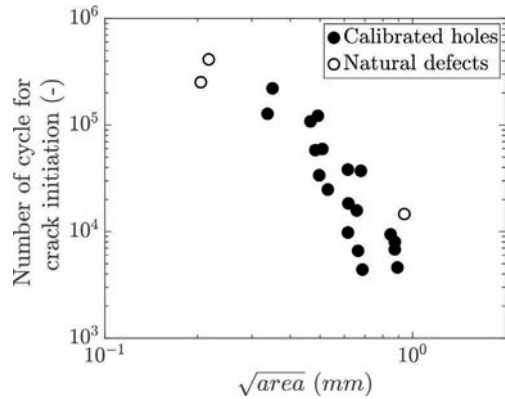
Figure 10. Defect $\sqrt{\text{area}}$ influence on the number of cycles for fatigue crack initiation.

Finally, in the literature concerning the fatigue of metals described in the introduction (Murakami and Endo 1980, Murakami et al. 1989, Billaudeau et al. 2004), it is shown that defects size have no influence anymore on the fatigue lifetimes below a certain size. The results obtained for the studied EPDM in Figure 10 only confirm an increasing duration life with decreasing size of defect. But no assumption can be made on how defects with $\sqrt{\text{area}}$ below 200 would influence the fatigue resistance. Also, a fundamental difference between rubbers and most of metallic materials is the absence of fatigue limit for rubbers, which could explain the absence of thresholds in the fatigue properties of rubbers. The possible existence of a plateau or the continuation of the slope on the left hand part of the Figure 9 remain open questions. In fact, the influence of these small defects sizes is very hard to investigate. Indeed, for
