Influence of defects size on the fatigue properties of an industrial EPDM

Thomas Balutch, Bertrand Huneau, Yann Marco, Pierre Charrier, Clément Champy

Thomas Balutch, Bertrand Huneau, Yann Marco, Pierre Charrier, Clément Champy. Influence of defects size on the fatigue properties of an industrial EPDM. 11th European Conference on Constitutive Models for Rubber (ECCMR 2019), Jun 2019, Nantes, France. 10.1201/9780429324710-62 . hal-02304552

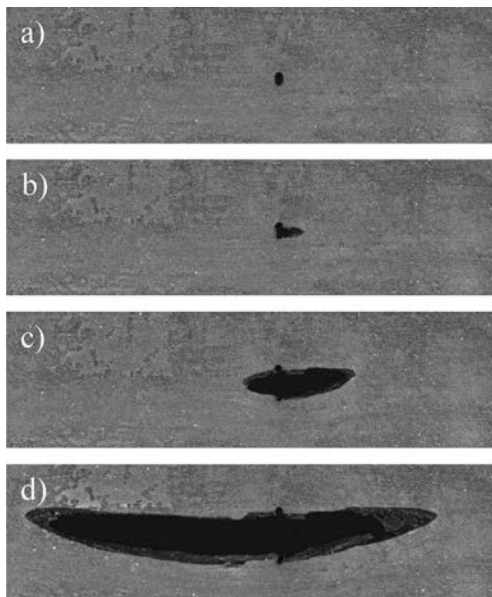
Figure 5. PS sample with a 0.2 mm hole at a) N = 0 cycle b) N = 109 400 cycles c) N = 112 600 cycles and d) N = 116 400 cycles.

Secondly, a damage description is proposed on Figure 5 thanks to regular pictures taken during fatigue tests. A first fatigue crack initiates on one side of the calibrated defect (Figure 4b), and few cycles later, another crack initiates on the opposite side (Figure 5c). They finally both propagate until final failure occurs. Figure 5d shows the sample just before failure. Each sample exhibits only one root cause of failure.

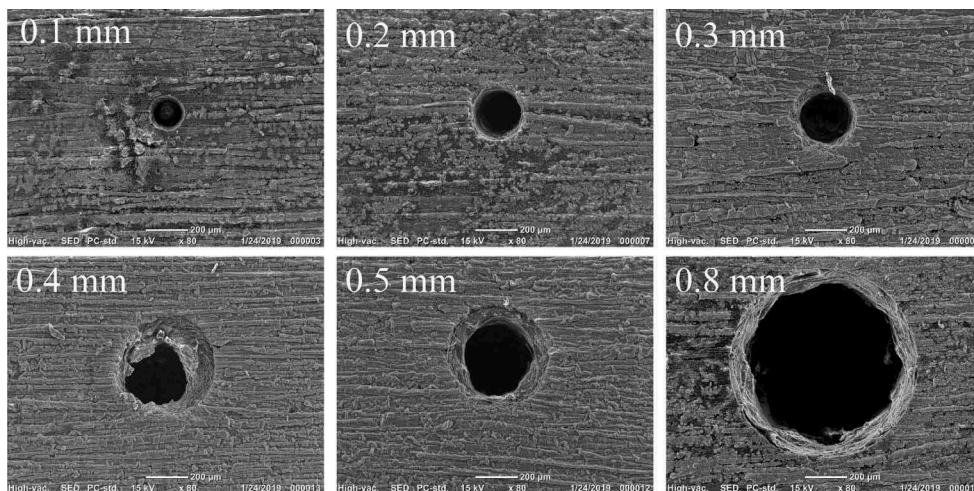
Figure 4. SEM pictures of the different hole sizes at the same magnification (x80).

In the first place, it has to be noted that small calibrated defects of good quality are successfully obtained. SEM pictures of all the tested defects sizes are presented in Figure 4. The rubber around the holes seems not burned or dragged by the drilling. This can only be obtained by performing the drilling in the glassy state of the rubber as mentioned in the methods section.
